An unexpected accidental ingestion of dental crown with loop: A clinical image

Journal: Journal of Case Reports and Medical Images

Clinical Image Description

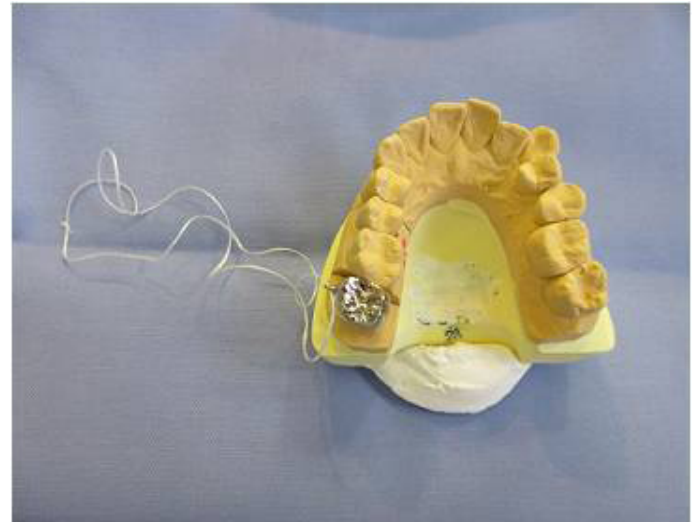
Figure 3: Prevention method of accidental ingestion in our dental hospital

Although ingested foreign bodies usually pass through the gastrointestinal tract uneventfully, it can sometimes cause serious complications [1]. Therefore, as prevention method of accidental ingestion, our hospital is supposed to tether a crown with dental floss ligature using the loop as the attachment, during dental treatment (Figure 3). In this clinical case, during fitting the crown in oral cavity, dental floss was removed before finishing the procedure due to the difficulty the manipulation, and thereafter an accidental ingestion of crown with loop unexpectedly occurred. Thus, we think that dentist should tether dental floss into the loop during dental procedure.
