An Aberrant Crossover Path of Right Subclavian Venous Catheter

Journal: Journal of Case Reports and Medical Images

Clinical image description

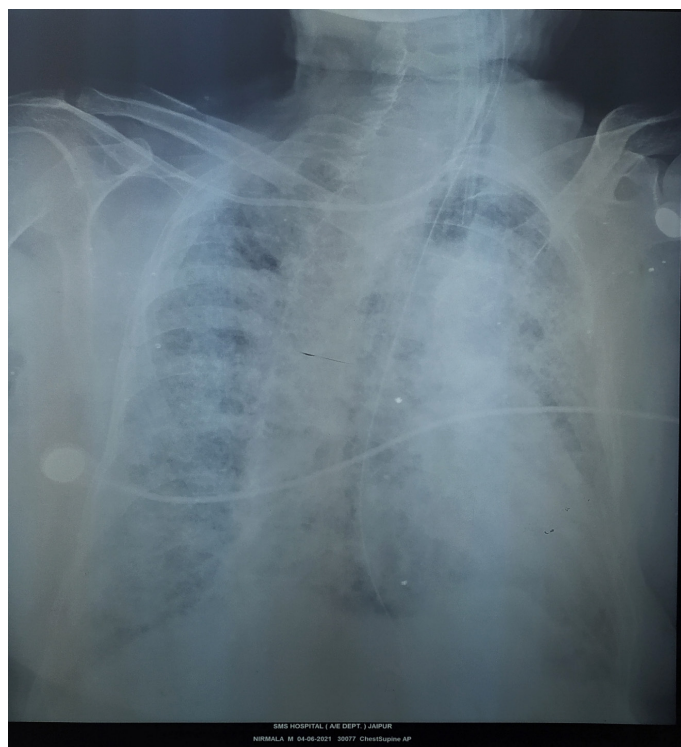
Figure 1: Chest X-ray AP view showing right subclavian venous reaching left internal jugular vein.

backflow of venous blood. Backflow was present in two (proximal and distal) of the three ports (proximal, medial and distal). Catheter was fixed and a chest X-ray AP view was ordered for the patient to check for the location of catheter. Chest X-ray revealed the catheter travelling from right subclavian vein to left internal jugular vein. Vital parameters were stable, therefore, the catheter was left in place. The patient received IV fluids, IV drugs and infusions through the catheter. No post procedural complications were reported.
